TRANSACTIONS

CIVIL ENGINEERS.

VOL. LIII.

No.		PAGE.
978	**THE COLLAPSE OF A BUILDING DURING CONSTRUCTION.**	
	By **H. de B. Parsons**	1
	Discussion on Paper No. 978:	
	By Nathaniel Roberts	10
	C. J. Tilden	13

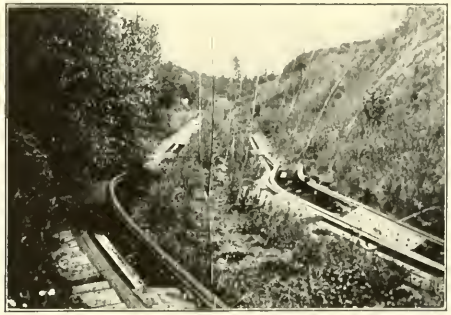
The photograph, Fig. 2, Plate XIX, looking west, shows the angle in the cable-railway track just east of Shaft No. 6. The pressure of the slide had warped the track out of position, the rails having been bent to the south. When this movement was first observed, September 25th, 1895, the lateral movement of the rail amounted to about 6 ins. As shown in the photograph, the rail is 18 ins. from the original position, measured at an angle of 60° from the horizontal. A similar movement of the north track had taken place, but it does not show in the photograph. Toward the top of the picture a vertical bend in the south rail of the south track can be distinguished. This point is at the east side of the "ball ground" landing, where there is a break in

Fig. 2.—Cable Railway East of Shaft No. 6.
June 24th, 1898.
